EXISTING AGRICULTURAL DRAIN TILE INVESTIGATION PLAN

GRAYSLAKE HOA

EXISTING SUBSURFACE AGRICULTURAL DRAIN TILE INVESTIGATION REPORT

GRAYSLAKE HOA / CBBEL, FIELD FILE NO. 10-2-14, DATE: 7/14/25, IN ACCORDANCE WITH LAKE COUNTY STORM WATER COMMISSION DRAIN TILE INVESTIGATION STANDARDS. COPYRIGHT © 2025, BY HUDDLESTON MCBRIDE LAND DRAINAGE SERVICES

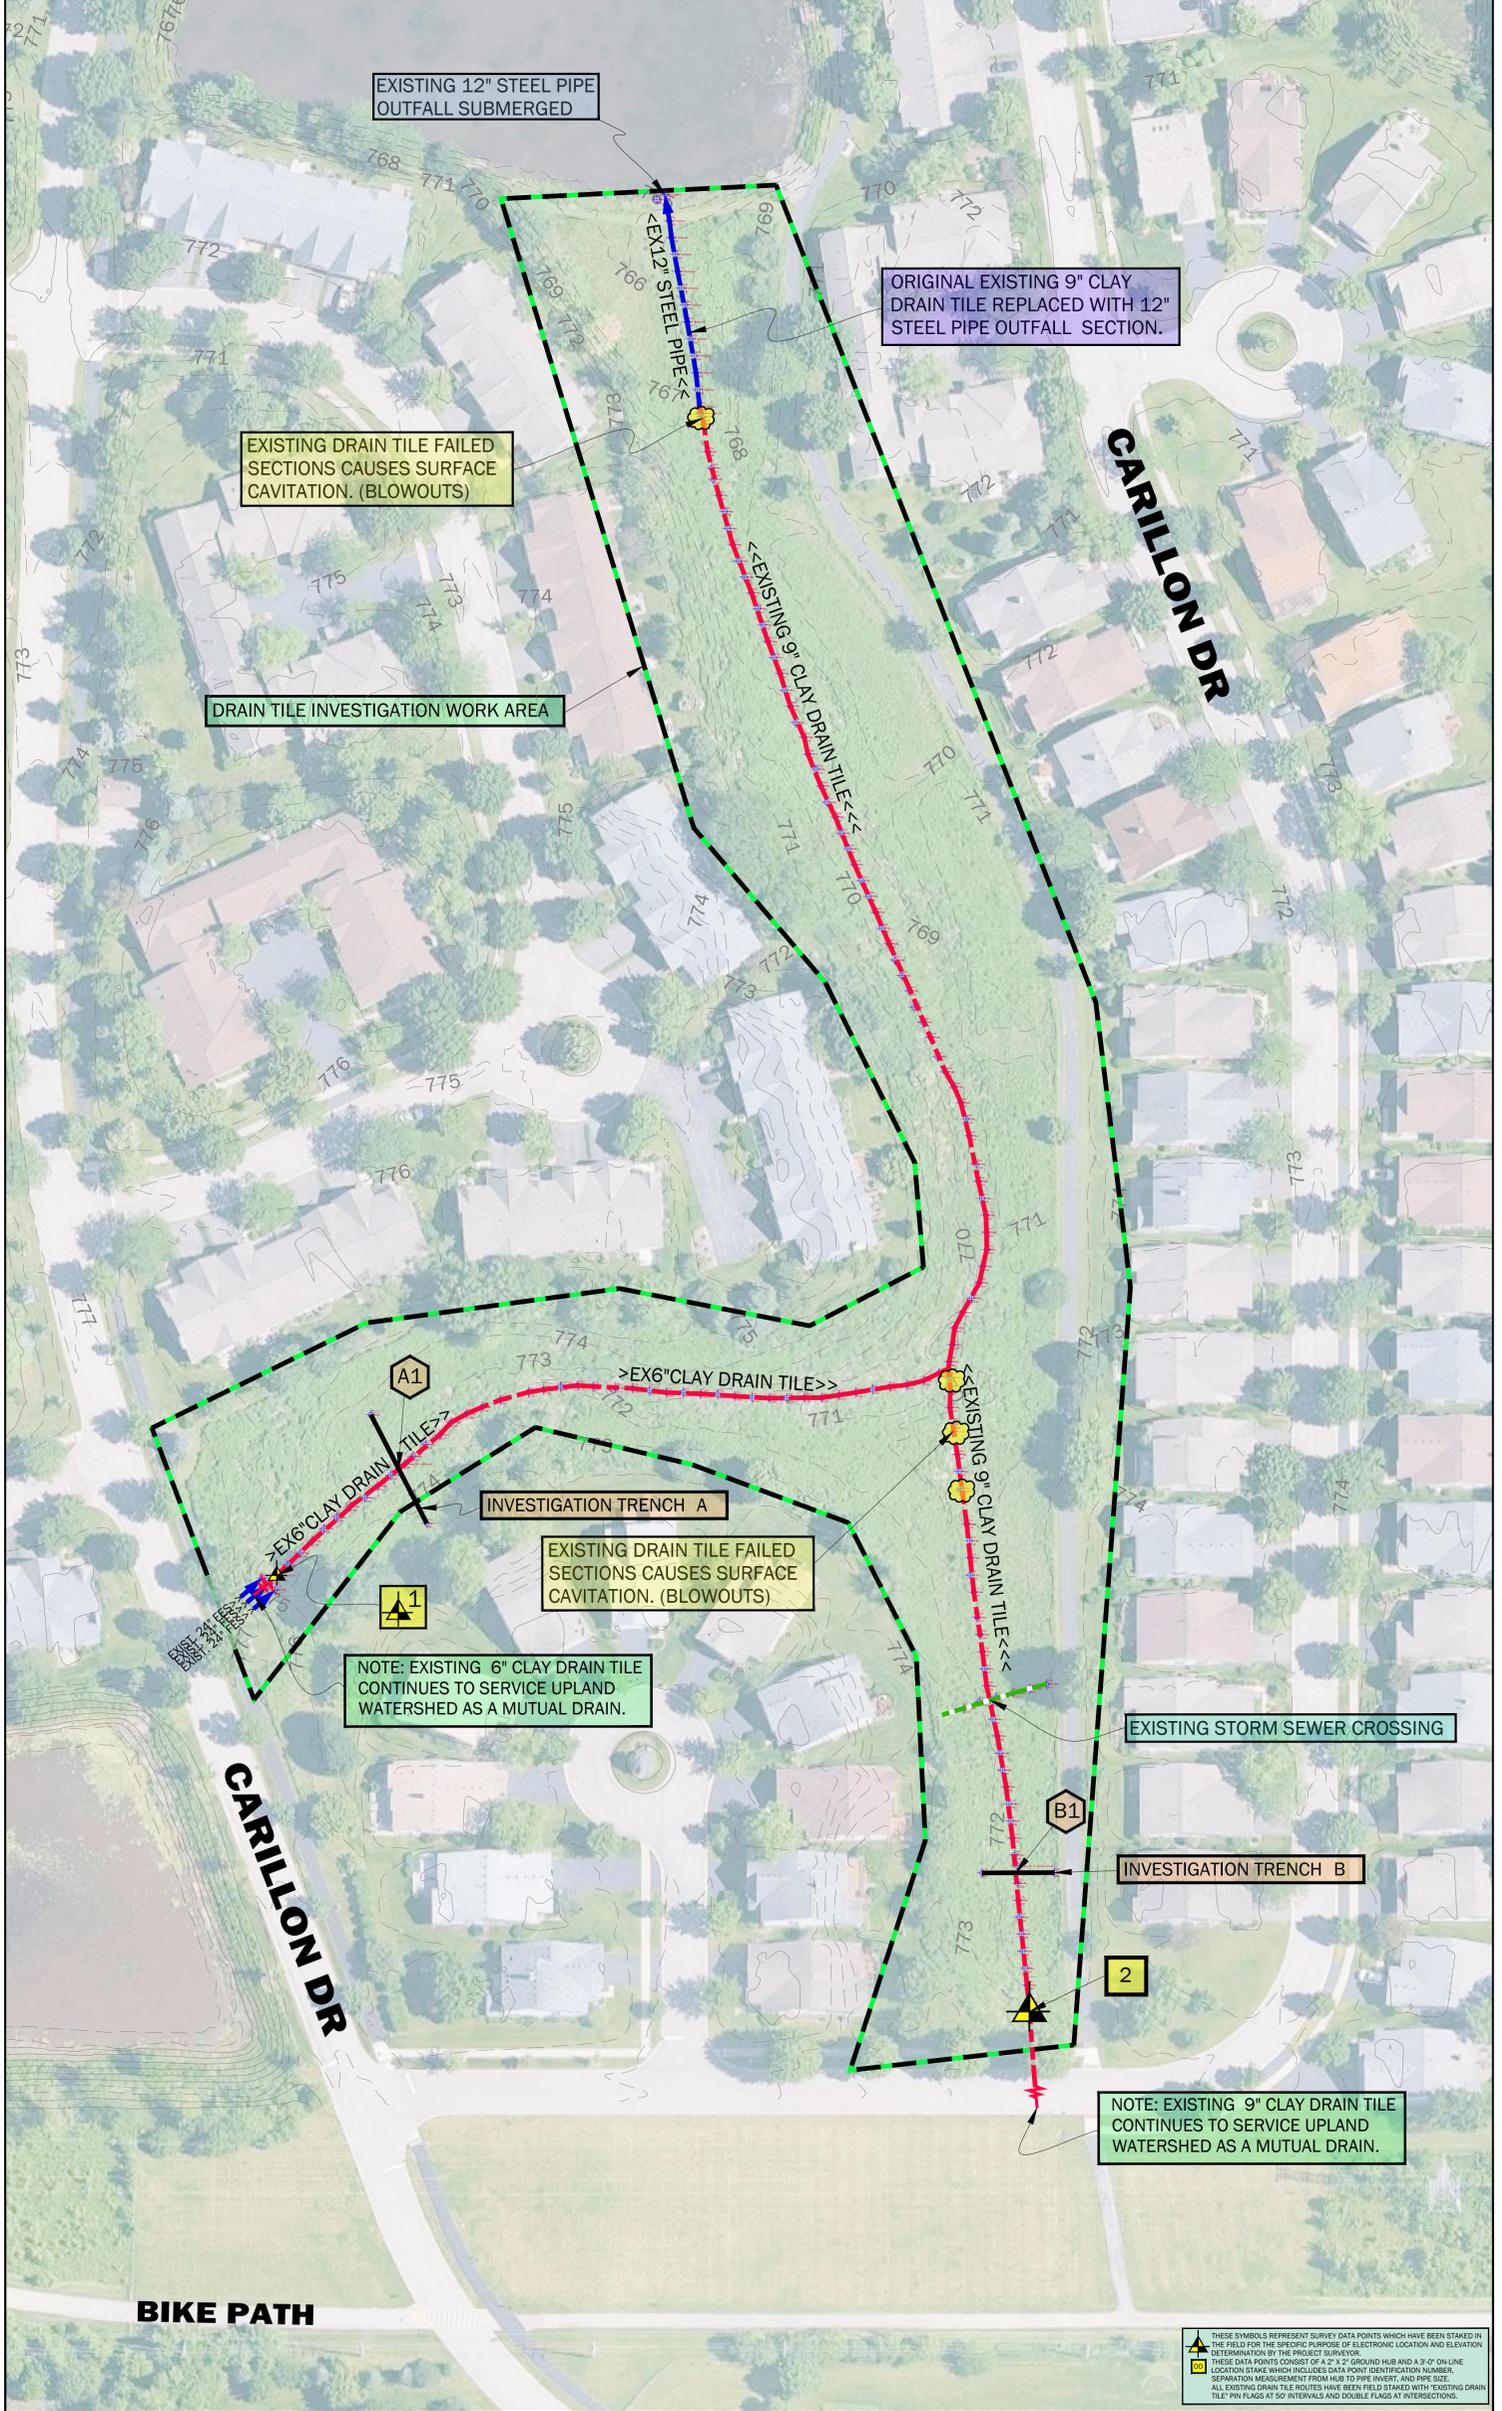
ID NO.	SZ.	TYPE / QUALITY	FLOW %	SILT %	DEPTH (IN)	FIELD NOTES:
A1	6"	CLAY / GOOD	SLIGHT	SLIGHT	42"	ACTIVE FLOW RATE AND CAPACITY
B1	9"	CLAY / GOOD	FLOODED	20%	59"	RESTRICTED FLOW AND SURCHARGED

DATA POINT	SZ.	TYPE / QUALITY	FLOW %	SILT %	DEPTH (IN)	FIELD NOTES:
1	6"	CLAY / GOOD	SLIGHT	SLIGHT	42"	LATERAL AT PROPERTY INGRESS
2	9"	CLAY / GOOD	FLOODED	20%	59"	MAINLINE AT PROPERTY INGRESS
