**SITE INVESTIGATION
COMPLETION REPORT**

**VILLAGE OF LAKE ZURICH
61 WEST MAIN STREET
LAKE ZURICH, LAKE COUNTY, ILLINOIS 60047
LUST INCIDENT No. 20100090
IEPA LPC No. 0970855130**

July 12, 2010

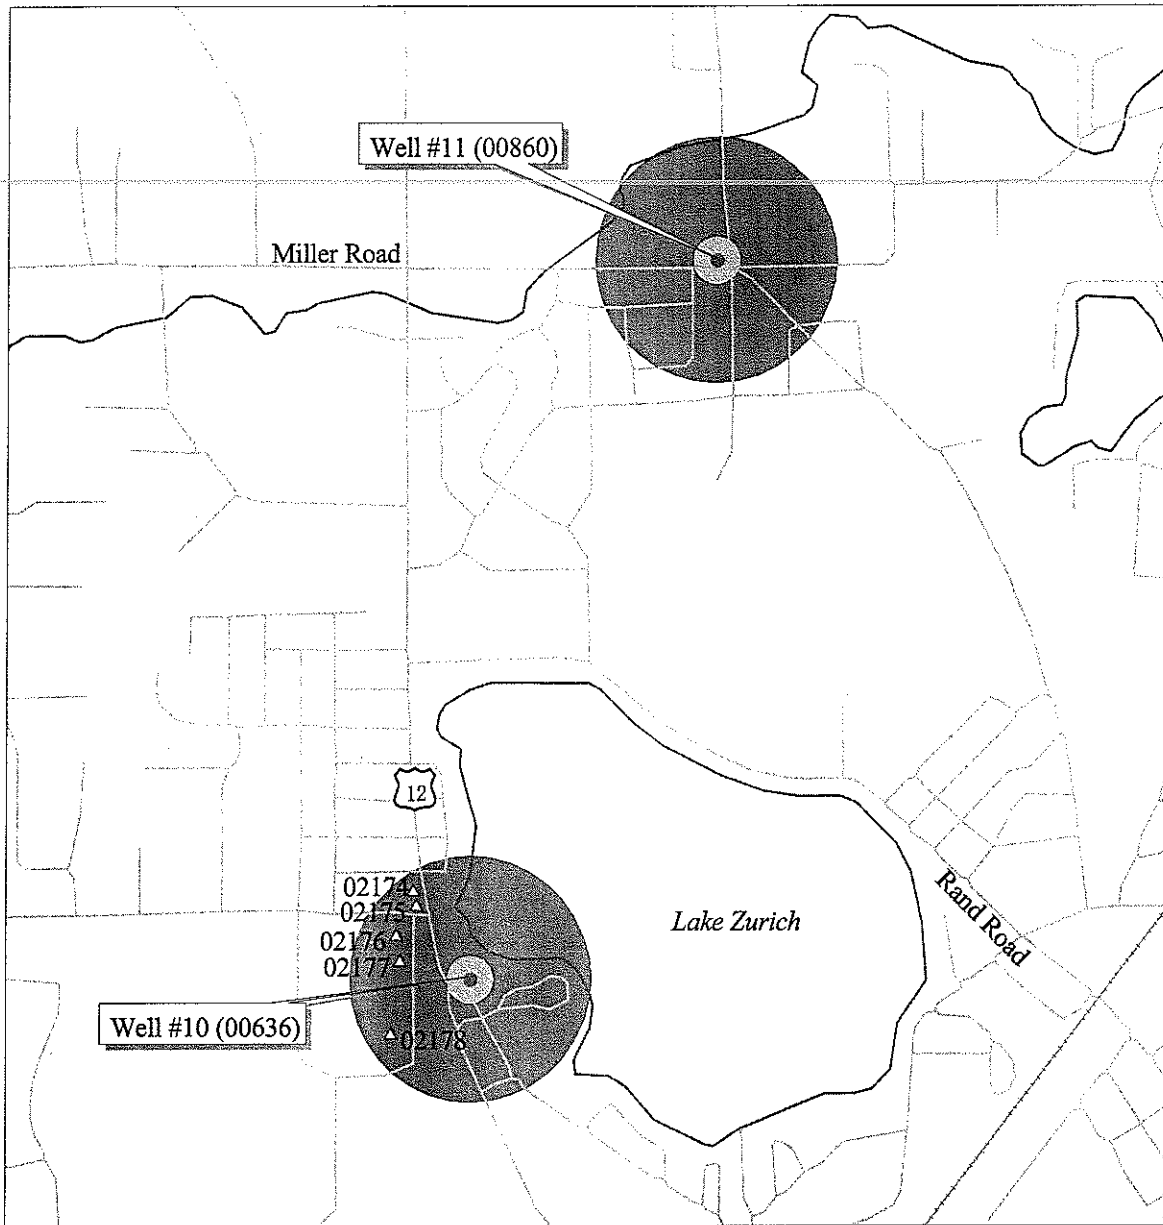
**FIGURE 3: WELLHEAD PROTECTION PLANNING MAP
FOR LAKE ZURICH (FACILITY #0970850c)**

Roads, Rails, and Streams from Illinois DNR.
CWS Wells and Potential Sources from Illinois EPA.
Map compiled by Groundwater Section, Illinois EPA.
