## Stormwater Infrastructure Repair Fund Eligibility Authorization Form

Applicant Jurisdiction (s) (Community, Township, HOA)	Village of Beach Park		
Brief Project Title	Ravine and Streambank Site Restoration		
General Location	9950 and 9968 Marguerite Lane in Beach Park Illinois		
Contact Person	Ernesto Huaracha		
Address	500 W. Winchester Rd, Ste. 201		
City, State Zip	Libertyville, IL 60048	Phone	847-377-7700
<b>Resource Request</b>			
<input type="checkbox"/> SIRF Funds <input type="checkbox"/> SMC Staff Capacity <input checked="" type="checkbox"/> Combination Funds and Staff			
<p>Project Description (use additional sheets if necessary):</p> <p>The Lake County Stormwater Management Commission (SMC) is applying for SIRF funds for this project. SMC will receive funds from the Village of Beach Park for this project as a part of, and has also been awarded funds associated with FEMA's Hazard Mitigation Assistance Program to acquire flood-prone properties at 9950 and 9968 Marguerite Lane in Beach Park, IL to demolish and clear any remaining structures, converting the subject properties to permanent "green space".</p> <p>This section of the Bull Creek ravine is experiencing severe e

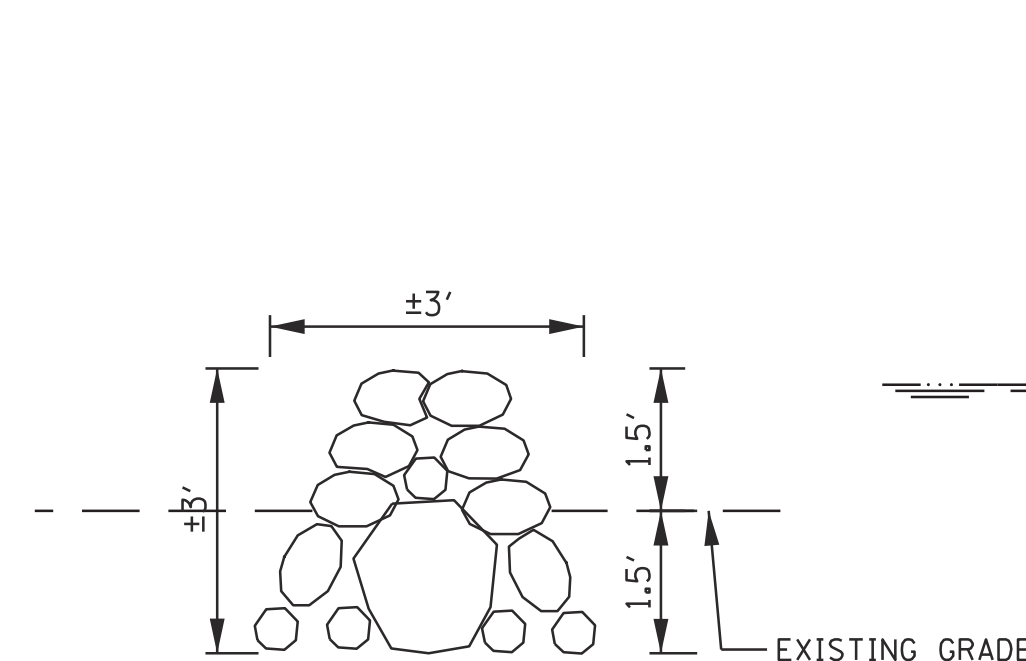
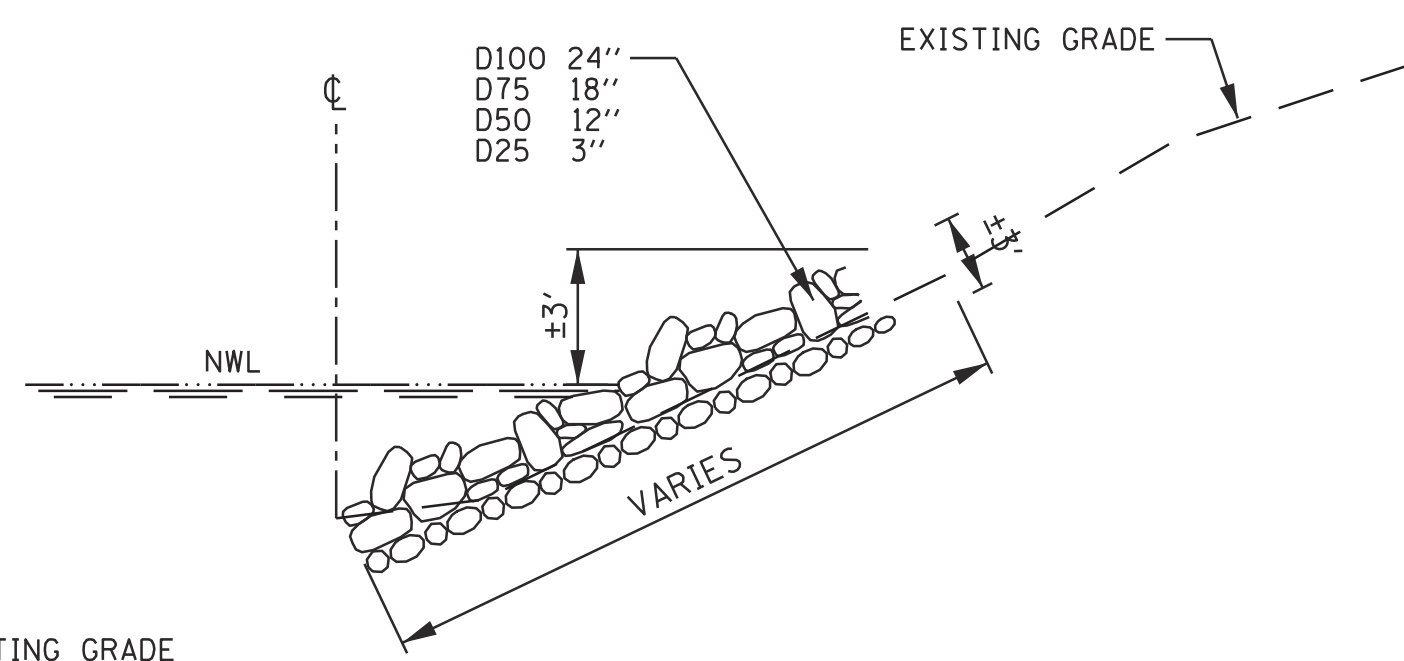
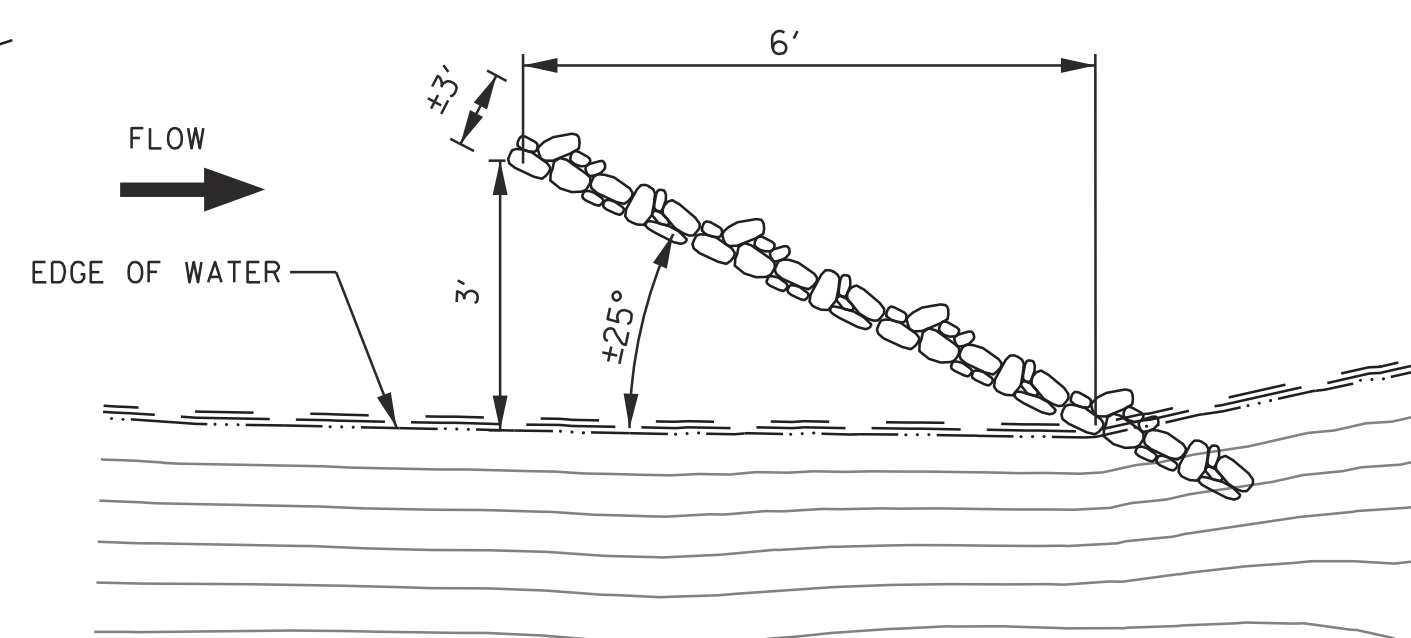
1. ALL VANES SHALL DIMENSIONALLY MATCH VANE 1 CONSTRUCTION AS, SHOWN ABOVE, IN THE DETAILS AND DESCRIBED BELOW.
2. THE VANE HEAD SHALL BE PLACED 3 FEET FROM THE TOE OF THE SLOPE.
3. THE VANE FROM THE HEAD TO THE TOE OF THE SLOPE SHALL BE 6 FEET AS MEASURED ALONG THE BANK.
4. THE VANE SHOULD EXTEND AND BE BURIED IN TO THE TOP OF THE BANK.
5. VANE SPACING IS PER PLAN.
6. SEE VANE DETAIL FOR CONSTRUCTION REQUIREMENTS.
